**TESTING OF CONTAINMENT
CAPABILITIES OF REINFORCED
CONCRETE-SHIELDED ENCLOSURES**

ANL-6664
Reactor Technology
(TID-4500, 19th Ed.)
AEC Research and
Development Report

Reactor Engineering Division

March 1963

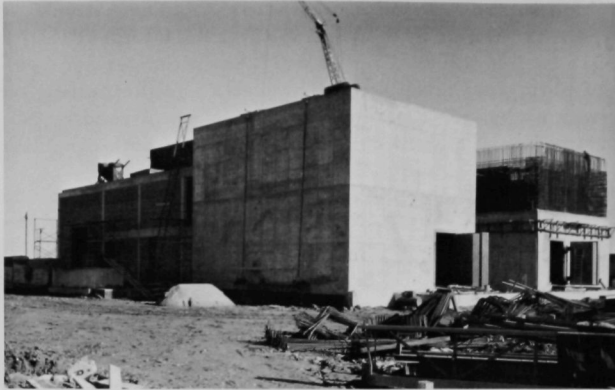
111-9988

Fig. 3. Outside View of Completed Cell No. 5. To the Right, Twin Cell No. 4 under Construction

Figures 1, 2, and 3 show the twin cells No. 4 and No. 5 under construction. Each cell possesses a large, thick, steel service door on the

During construction an effort was made to employ techniques consistent with accepted good practice in the mixing, transportation, and placement of concrete. Concrete possessing a compressive strength of 4000 psi at 28 days was specified. To minimize possible planes of weakness originating at construction joints, two continuous pouring operations were employed, the only construction joint being located at approximately midheight of the walls. Special effort was expended to insure continuity at the joint by providing extra reinforcing. Also, prior to the second pour, the first joint surface was vacuum cleaned, wetted, and grouted. Subsequently, the tests did not disclose a plane of weakness resulting from the presence of the construction joint. Figure 3 shows the completed cell No. 5 and its twin cell No. 4 under construction.
